# Technical Bulletin

## Replacing i9500

### Pinpad and card reader

**Technical Bulletin N°:** CTB1051  
**Date of issue:** 09/01/13  
**Revision:** 1.0  
**Author:** W.Zheng

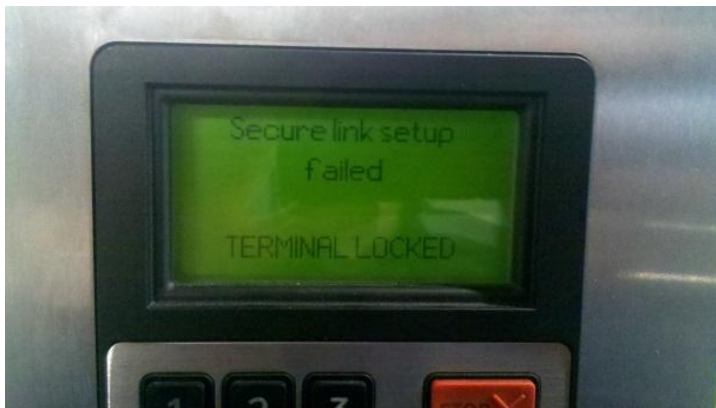
1. When the i9500 Pinpad is displaying “Secure link setup failed TERMINAL LOCKED”, it indicates that either the Pinpad, card reader or both units have been tampered and will need to be replaced.

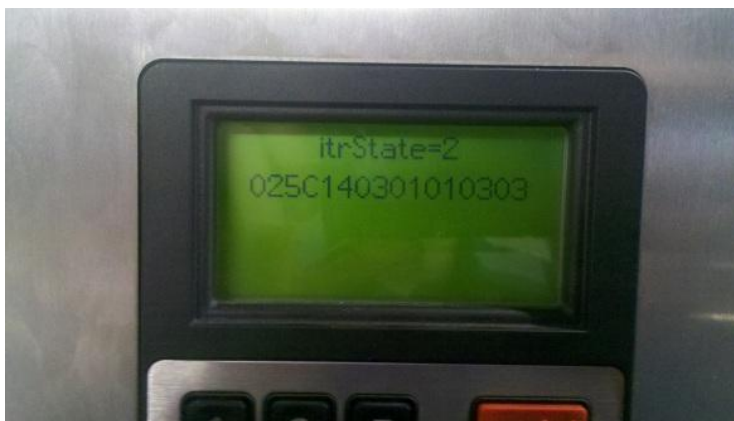
2. Repower the OPT and look for the ITR state that will be displayed on the Pinpad.

The ITR state determines which unit/s has failed and need to be replaced.

- ITR State = 0 – Both Pinpad and card reader
  - ITR State = 1 – Pinpad
  - ITR State = 2 – Card reader
3. Call Compac and report the following information:
    - ITR state as this will be needed when Compac requests replacement units from DPS.
    - Serial number of the faulty unit and the replacement unit.

- There should be two service removal cards sent with the Pinpad and card reader. You will need to give the card numbers to Compac if the Pin numbers for these cards are not provided already.
4. Replace the faulty unit and any additional part requested by Compac and then deactivate the alarms on the replacement Pinpad and card reader with the service removal cards by following the instructions on the Pinpad. This may need to be completed twice to deactivate the alarms on both the pin pad and the card reader.
